Summary Test Report
Ball Joint Life Cycle Test
Solar Plant Installations

A Hyspan Barco Ball Joint, drawing number 58840 Rev. D, was tested under conditions simulating the operating environment of the heat transfer fluid piping that connects the solar collectors to the main header, and to the crossover pipe between adjacent rows of parabolic collectors on solar fields.

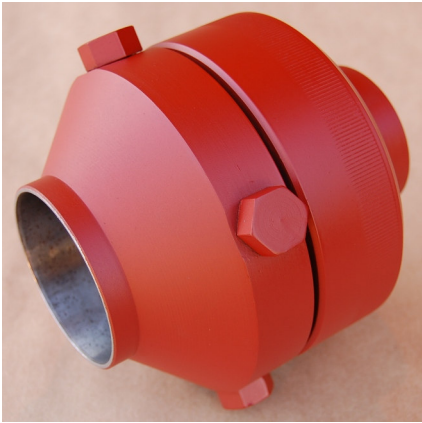
Hyspan Barco 2" NPS Ball Joint designed for solar collector applications life cycle tested for 30 years (11,095 cycles) service.

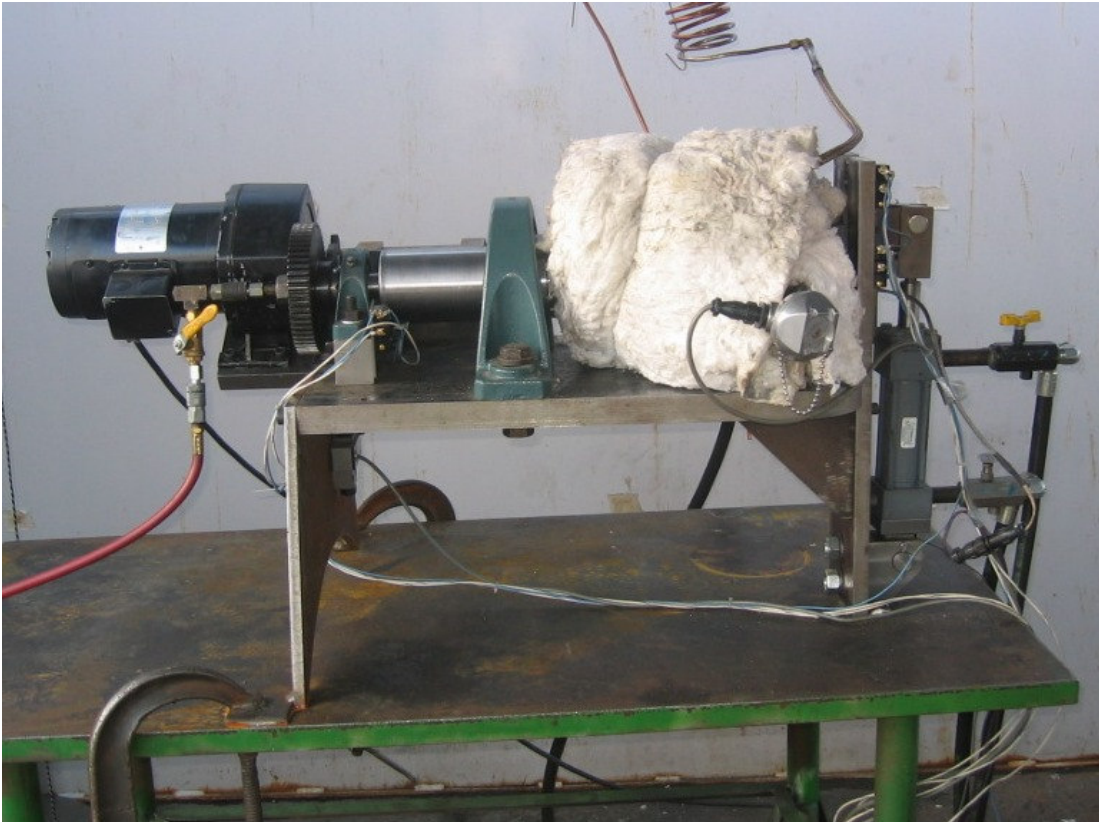
Life cycle test rig capable of $\pm 7^\circ$ angular travel and 215° rotational while operating at pressures and temperatures up to 30 Bar and 393°C . Continuous measurement of angular and rotational torque.
